Contract #: 04-0120F4Cty: SF/ALA Rte: 80 PM: 13.2/13.9File #: 69.28**WELDING INSPECTION REPORT****Resident Engineer:**Siegenthaler, Peter**Address:** 333 Burma Road**City:** Oakland, CA 94607**Report No:** WIR-024348**Date Inspected:** 08-Jun-2011**Project Name:** SAS Superstructure**OSM Arrival Time:** 700**Prime Contractor:** American Bridge/Fluor Enterprises, a JV**OSM Departure Time:** 1900**Contractor:** Zhenhua Port Machinery Company, Ltd (ZPMC), Changxing Island **Location:** Shanghai, China**CWI Name:** Zhu Zhong Hai**CWI Present:** Yes No**Inspected CWI report:** Yes No N/A**Rod Oven in Use:** Yes No N/A**Electrode to specification:** Yes No N/A**Weld Procedures Followed:** Yes No N/A**Qualified Welders:** Yes No N/A**Verified Joint Fit-up:** Yes No N/A**Approved Drawings:** Yes No N/A**Approved WPS:** Yes No N/A**Delayed / Cancelled:** Yes No N/A**Bridge No:** 34-0006**Component:** Orthotropic Box Girder( OBG)**Summary of Items Observed:**

OBG TRIAL ASSEMBLY YARD

## WELDING INSPECTION REPORT

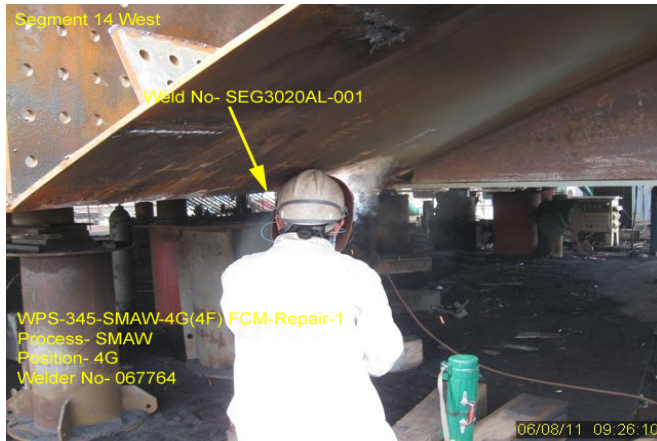
This QA Inspector observed ZPMC qualified welding personnel identified as 067764 perform Shielded Metal Arc Welding (SMAW), weld joint identified as SEG3020AL-001 ; located On Orthotropic Box Girder (OBG) Bottom Plate to Side Plate CJP Weld; ZPMC Quality Control (QC) is identified as Mr. An QinXiang. This QA Inspector observed the base material appears to have been preheated by an electrical heating element prior to welding. The Welding Repair Report (WRR) was B-WR21196.ZPMC Quality Control (QC) Mr. An QinXiang was onsite monitoring the welding variables. The welding variables recorded by QC appeared to comply with applicable WPS-345-SMAW-4G (4F) FCM-Repair-1. See attached photo for further details.

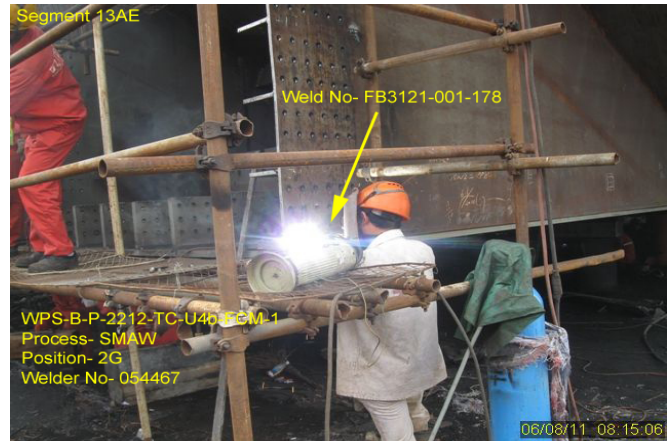
This QA Inspector observed ZPMC qualified welding personnel identified as 054467 perform Shielded Metal Arc Welding (SMAW), weld joint identified as FB3121-001-178 ; located On Orthotropic Box Girder (OBG) X3407A to X3318B CJP Weld; ZPMC Quality Control (QC) is identified as Mr. Li Yang. This QA Inspector observed the base material appears to have been preheated by an electrical heating element prior to welding. ZPMC Quality Control (QC) Mr. Li Yang was onsite monitoring the welding variables. The welding variables recorded by QC appeared to comply with applicable WPS-B-P-2212-TC-U4b-FCM-1. See attached photo for further details.
